**Targeted Brownfield Assessment  
Oklahoma Army National Guard  
Cushing Armory  
Cushing, Oklahoma**

**ASTM E 1527-05  
Phase I Environmental Site Assessment  
All Appropriate Inquiry**

**December 17, 2007**

**Oklahoma Department of Environmental Quality  
Land Protection Division  
707 N. Robinson  
P.O. Box 1677  
Oklahoma City, Oklahoma 73101-1677  
(405) 702-5100**

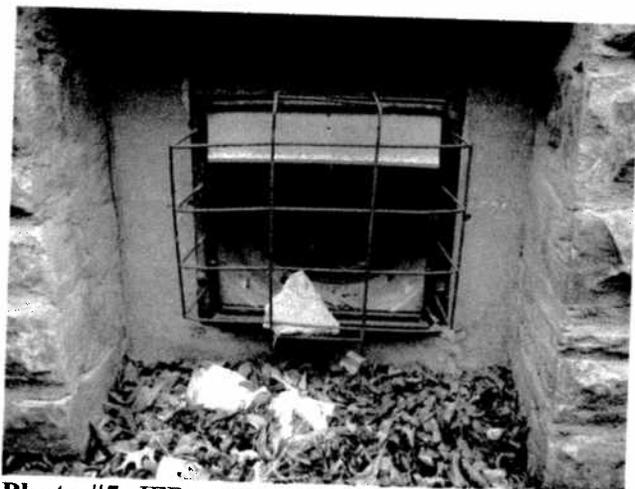
**Photo #5:** IFR vent.

- Evaluation of lead contaminated water inside the flooded IFR. The IFR vent and drainage alleys outside of the building may need to be analyzed for lead.
- A lead-based paint and lead dust abatement should be conducted at the Armory.
- The green POL portable storage safe should be disposed of in a landfill suitable for what is and was contained in the safe.
- The 9 x 9 inch floor tile and mastic found to have ACM should be removed.
- POLs, batteries, cleaning supplies, and detergent at the facility should be removed and/or properly disposed of by the OKARNG component of the Cushing Armory.
- Nonworking bulbs out of the approximate count of 44 fluorescent light bulbs in the Armory should be disposed of properly.

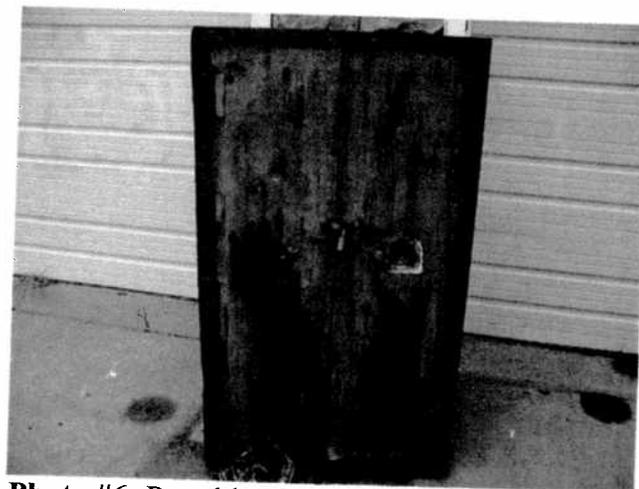
- A locked green portable POL storage safe located outside of the Motor Pool to the south contains ACM. It was mentioned this safe contained hazardous chemicals. A white friable substance was found inside the fireproofing of one of the safe doors. The suspect

**Photo #6:** Portable chemical storage locker with asbestos located on the south side of the building.

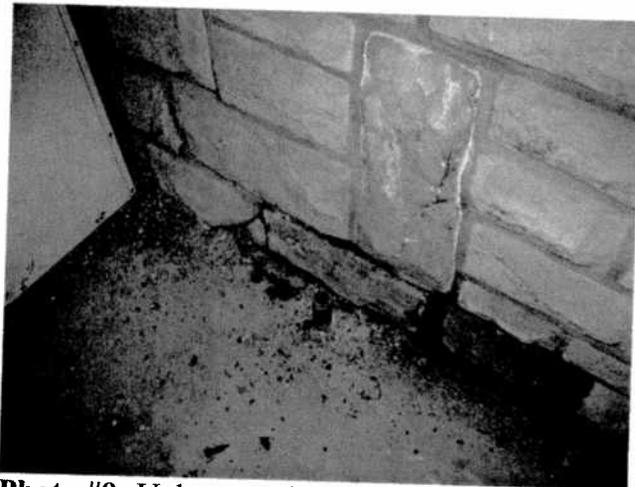
packaged and unpacked batteries of non-rechargeable lithium/sulfur/dioxide. Two heating units are located on the northeast and southwest corners. Staircase rails from the Drill Floor to the offices and classroom to the north contained peeling paint, which may contain lead. A demolition kit with what looked like a missile was found next to the east wall. Bruce Clary of the National Guard was called the day of the site visit to pick it up and did. Last thing noticed in the IFR was a one inch diameter metal pipe found above the Drill Hall floor on the southwest side. It is unknown what this pipe was used for.

**Photo #9:** Unknown pipe inside the Drill Floor.

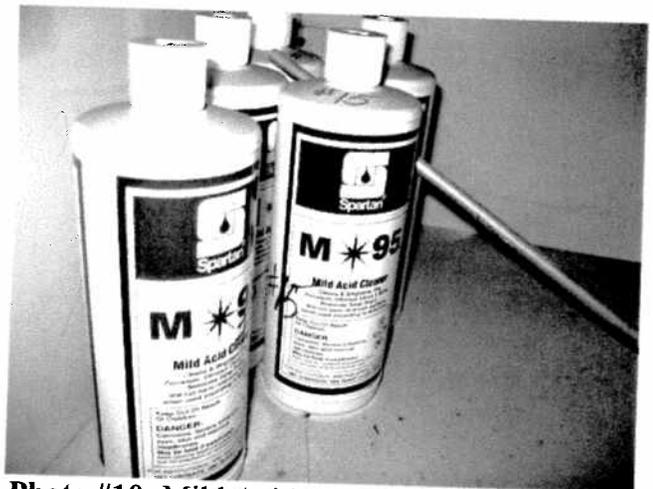
**Photo #10:** Mild Acid Cleaner inside one of the lockers in the Drill Floor.

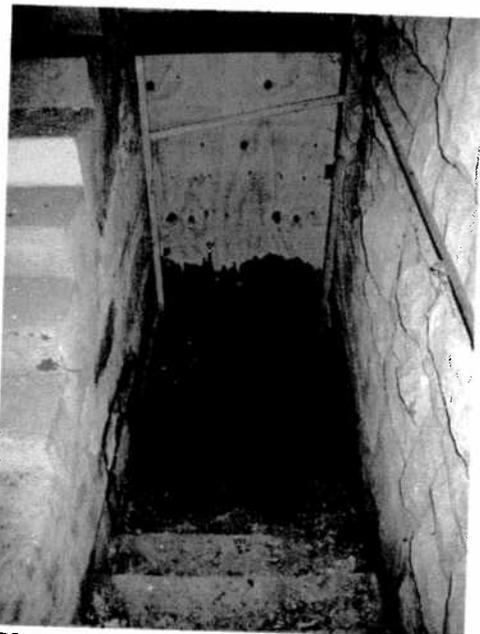
There is no known groundwater contamination. The IFR is 2/3 below ground surface (bgs). During the site reconnaissance, it was flooded approximately three feet high up several stairs leading into the Drill Hall. A water sample was collected on May 1, 2007, to analyze the lead concentration that may have dispersed throughout the water from the IFR bullet sand trap. The water sample taken from the IFR had a lead concentration of 0.0303 mg/L. This concentration is not considered to be hazardous waste. Lead concentrations of 5 mg/L are considered to be hazardous waste. The analytical results of the water sample are located in Appendix E. According to the floor plan of the Cushing Armory, a sump and pump is shown being inside the IFR. According to the key site manager of the Cushing Armory, Bruce Clary, the water from the sump was pumped out of the building into the north drainage alley where it then drained south through the east drainage alley into the gutters of Second Street. There is no surface water on the property or adjoining properties. Surface water was only found inside the flooded IFR.

**Photo #11:** Entrance to the flooded IFR.

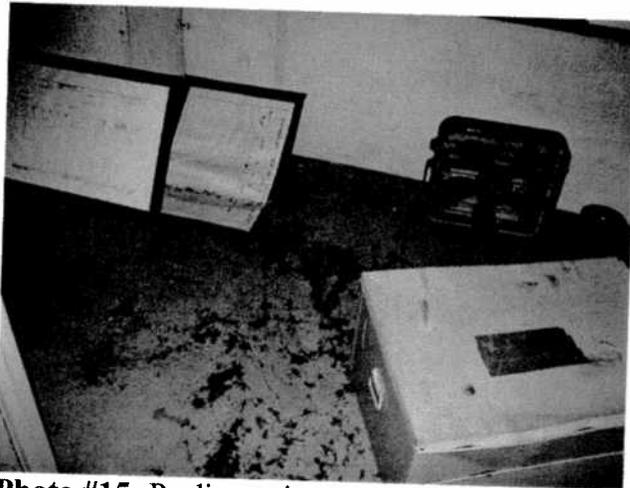
- Loose paint chips were found on the walls of the Squad Leader Room, Family Support Group Room, and the latrine south of the CO Room. Entry doors of the CO Room and the west Orderly Room have large sections of peeling paint. The floor in the closet of the Family Support Group Room has chipped paint. Rail guards from each staircase leading up from the Drill Floor to the offices and classroom have chipped and peeling paint. An XRF testing device for lead-based paint was used by Marshall Environmental inside the Armory. XRF readings greater than the EPA standard of 1.0 mg/cm<sup>2</sup> were located on the door and door frames of the Family Support Group Room, Library, Squad Leader Room, Bunk Room, Storage Room, CO Office, Main Latrine, and the Vault. The Drill Floor's door frames, stair handrails, overhead door frames, downspouts, windows, and portable safe outside tested positive for lead-based paint. Lead-based paint was also found from the following: CO Office Latrine door; ORD Room door frame; Recruiter's Office window; Hallway door frame; Main Hallway door and cabinets. The lead-based paint in these areas constitutes a REC.

**Photo #15:** Peeling paint on the closet floor east of the Family Support Group Room.

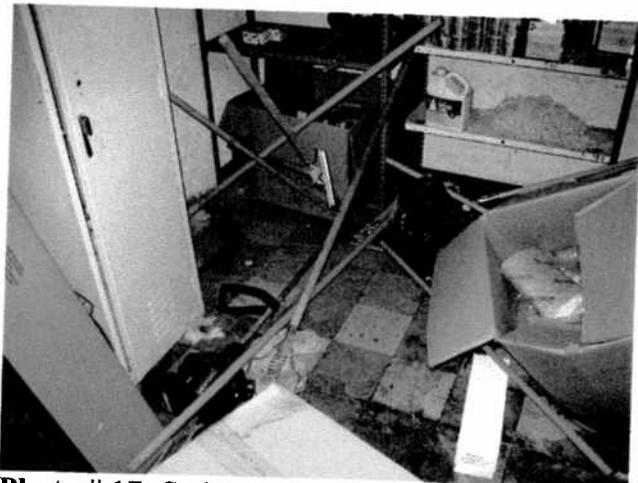
The 9 x 9 inch floor tile inside the Storage & POL Room had several stains. It is unknown what these stains are from. A gas containing weed eater was found on the floor where the stain was located. However, no odors of gasoline were noticed. Cleaning chemicals and other miscellaneous cleaning supplies comprise most of what is stored in this room.

**Photo #17:** Stained 9 x 9 inch floor tile inside the Storage and POL Room.

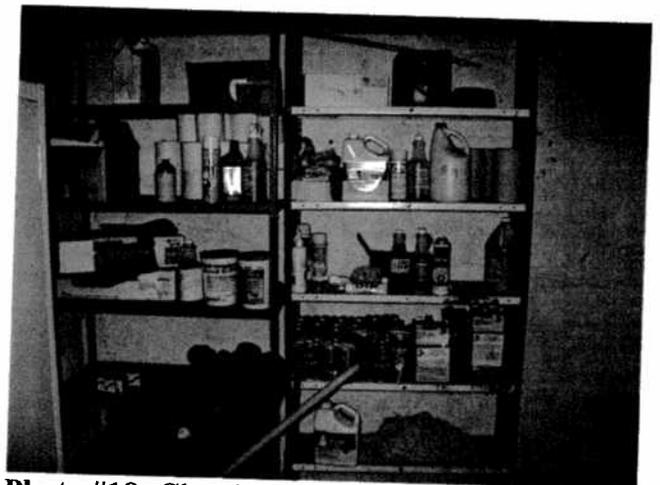
**Photo #18:** Cleaning products found inside the Storage and POL Room.

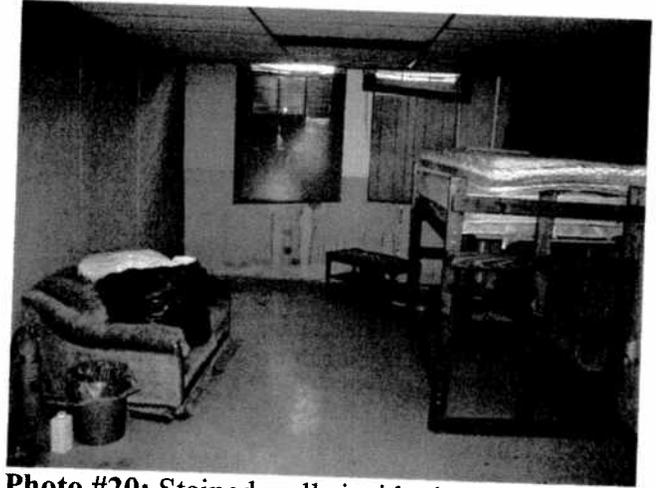
**Photo #20:** Stained walls inside the Bunk Room.

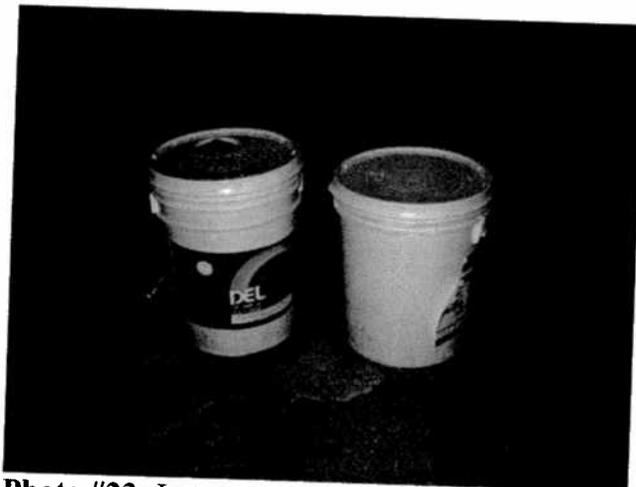
**Photo #23:** Latex enamel inside Motor Pool Room.

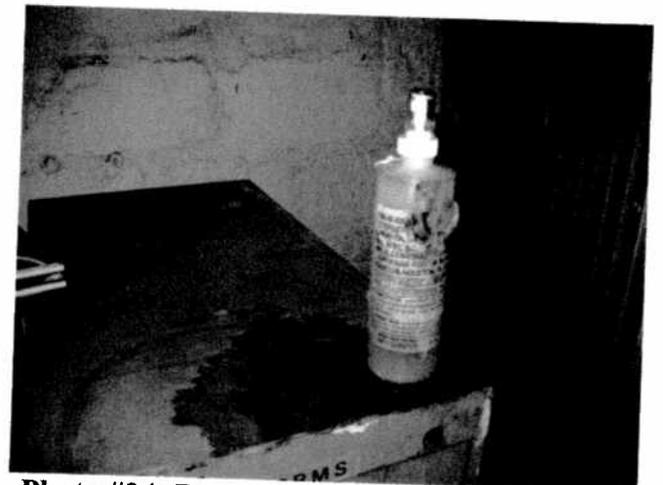
No chemical spills were observed outside the Armory building. No spills were reported on the property from the Emergency Response Notification System (ERNS) database either (Ref. 9). Minor stains and spills were found inside the building. Inside the Motor Pool a bottle of spray-on detergent containing sodium carbonate had a leak on top of a

file cabinet. The bottle label was corroded from the liquid. Stains left from the leak left corrosion and rust on the file cabinet. Other areas inside the Motor Pool contained absorbent litter on the concrete floor from past vehicle maintenance leaks.

**Photo #24:** Detergent leaking in Motor Pool Room.

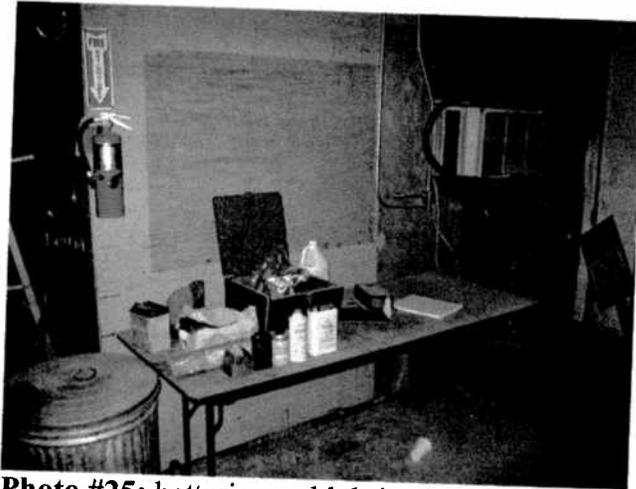
- Motorcycle power sport batteries were found in the Motor Pool. A packaged battery containing non-rechargeable lithium/sulfur/dioxide was found on the north side of the Drill Floor. No corrosion or leaks were found from these batteries.

**Photo #25:** batteries and lubricating oil found in the Motor Pool Room.

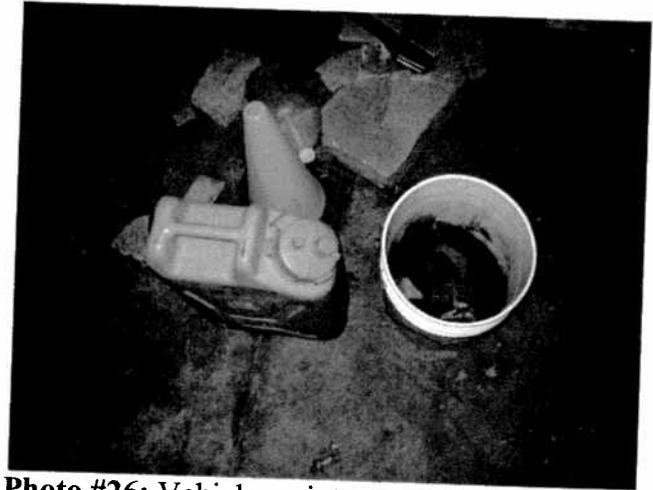
No stained soils were observed at the subject property. However, there were stained concrete floors inside the Motor Pool Room. Stains observed appeared to be old oil and grease stains from the servicing of vehicles.

**Photo #26:** Vehicle maintenance waste and water tank found in the Motor Pool Room.

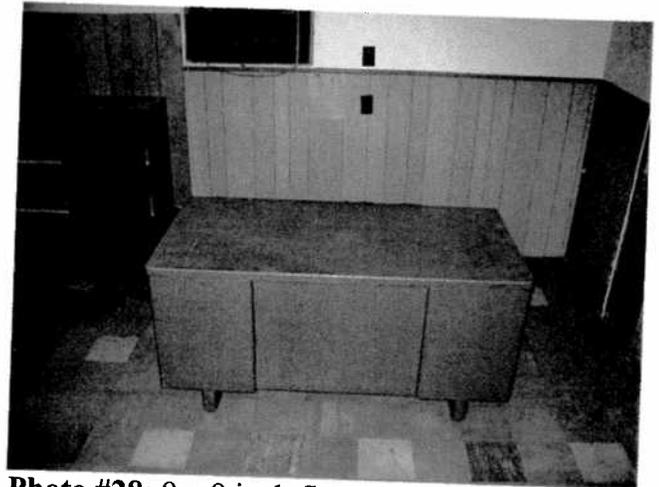
Marshall Environmental performed an asbestos inspection of the Armory. Fifteen of thirty-one asbestos samples collected from the armory were identified containing ACM. The black asphalt mastics and 9 x 9 inch floor tiles found inside the Family Support Group Room, Classroom, Squad Leader Room, Storage/POL Room, and the ORD/CO Offices contained more than 1 % of chrysotile asbestos. EPA's regulated concentration of asbestos in a material is 1 % or more. A green POL portable storage safe was found outside the building south of the Motor Pool Room. This safe supposedly was used to store hazardous chemicals. During the site visit, a white friable material was found inside one of the doors of the safe. Marshall environmental took a sample of the material and found it to have 55 % chrysotile Asbestos. The Marshall inspection results showed no presence of asbestos in the surfacing materials (blown on, textured or troweled onto building components e.g. ceilings and beams) or the thermal system insulation (TSI) (e.g. plumbing lines, HVAC equipment, boilers and steam lines) inside the Armory.

**Photo #28:** 9 x 9 inch floor tiles found in the Orderly Room.

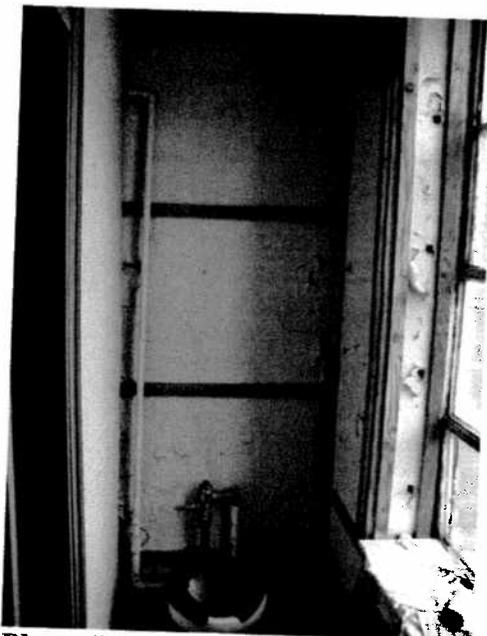
**Photo #29:** Peeling paint in the Latrine.

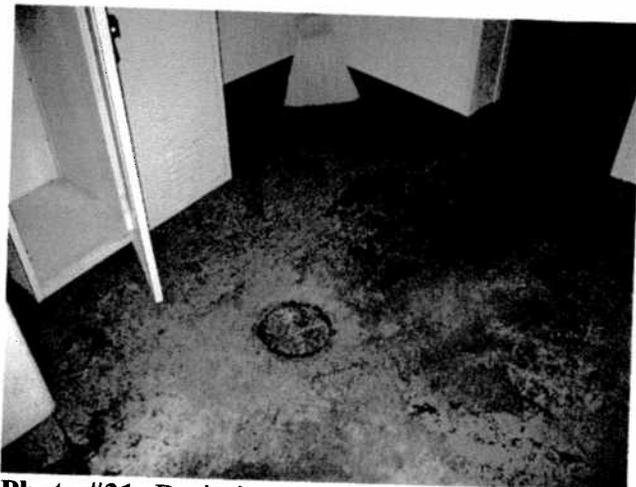
**Photo #31:** Drain in one of the latrines.

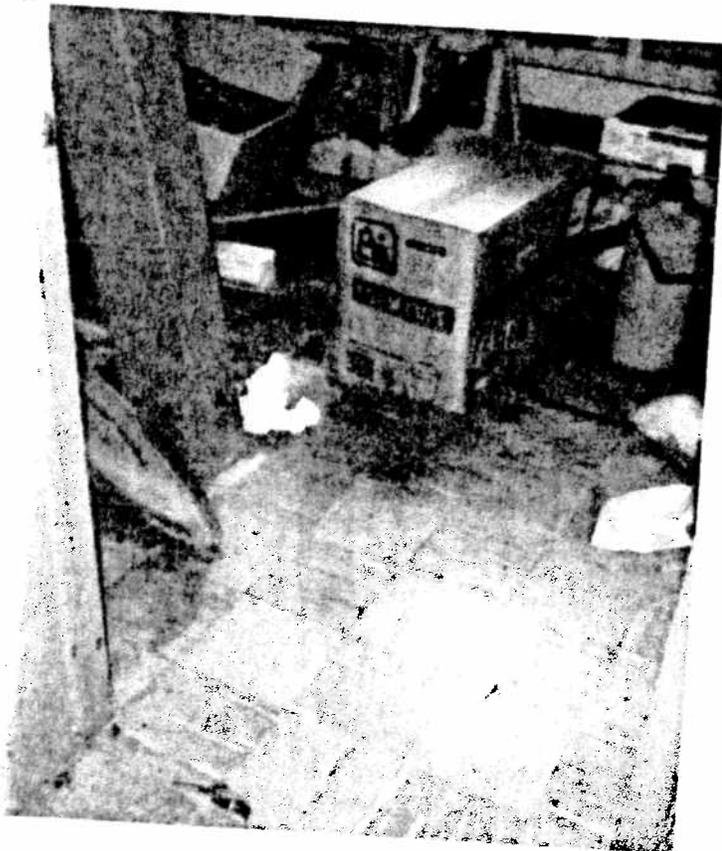
Storage/POL Room 9x9 Floor Tile

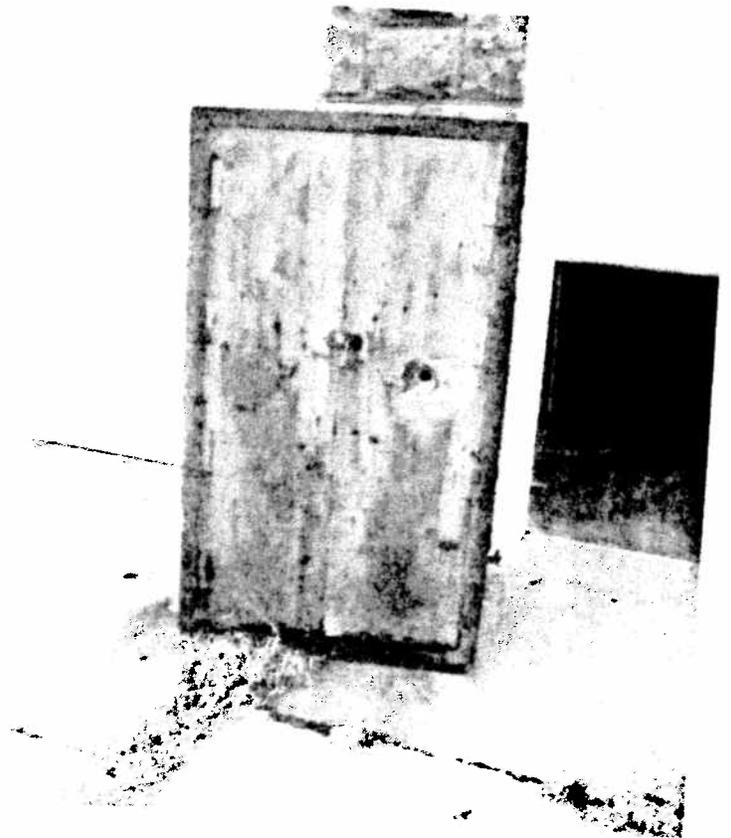
Outside of Motor Pool Damage Safe
